The Influence of Damage to the Geomembrane Layer on the Seepage Pattern and Discharge at the Homogeneous Embankment Dam

Abstract. Placing the geomembrane layer on the upstream slope can control the seepage in homogeneous dams. Poor geomembrane design, construction and maintenance caused damage to the geomembrane that caused a leak through the dam body. This study discusses the effect of damage on the geomembrane layer at the homogeneous embankment dam on the seepage pattern and discharge. The study location is in the Sianjo Anjo dam, Aceh Singkil district, a homogeneous dam with a geomembrane layer located in the dam body's upstream part. The damage of the geomembrane layer is assumed caused by the various defect of locations and size. The results show that the seepage pattern (phreatic line) tends to be weak in the geomembrane layer without damage. Meanwhile, if the geomembrane layer is damaged, the larger the defects' width, the higher the phreatic line. However, the seepage pattern that occurs shows insignificant or almost the same. The seepage discharge increases with increasing defect width and decreasing defect location.

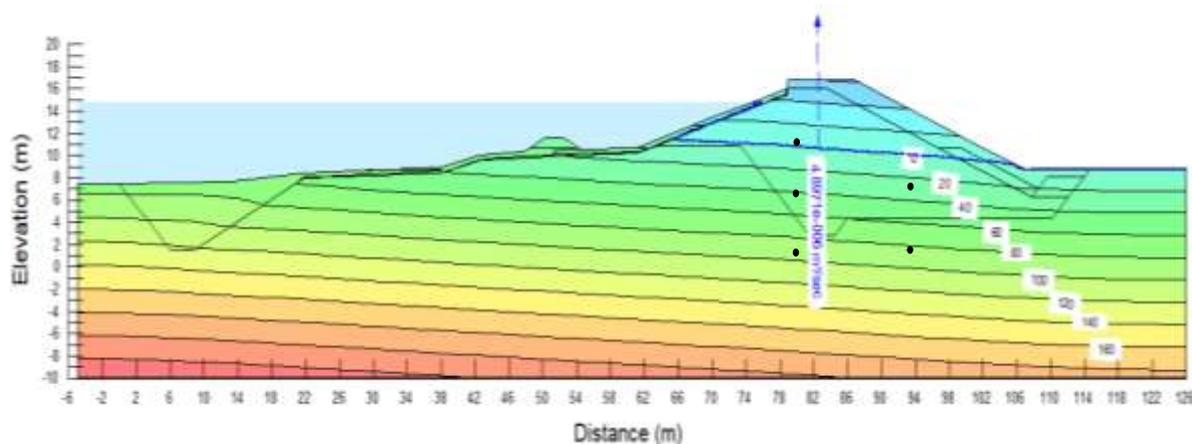
Figure 3. Analysis Result of Seepage in Existing Condition

The results of the seepage analysis of the existing conditions, as shown in Figure 3 show that if the geomembrane layer is not damaged, the phreatic level in the body of the dam tends to be lower. The seepage rate through the dam is 4.8971×10^{-6} m³/s/m. With a dam body length of 192.65 m, it was found that the seepage discharge was obtained of 0.943 l/s. Furthermore, the seepage discharge is close to the discharge measured on the v-notch instrument of 0.909 l/s.

The seepage analysis results under existing conditions (without damage) show that the dam body's phreatic level tends to be lower. The low phreatic level is because there is an intact geomembrane layer in the dam's upper reaches. The seepage analysis in the supposedly damaged geomembrane layer shows that the greater the defect's width, the higher the phreatic line. However, the flow patterns that occur show an insignificant difference or nearly the same. During this time, the seepage discharge that occurs shows that with an increase in the defect's width and a decrease in the location of the defect, the seepage discharge will increase. The results show that damage to the geomembrane layer will result in leakage through the dam body. Therefore, a good design, construction and proper maintenance of the dam body's geomembrane layer is necessary so that leakage through the dam body can be avoided so that the dam body's safety can be awake.

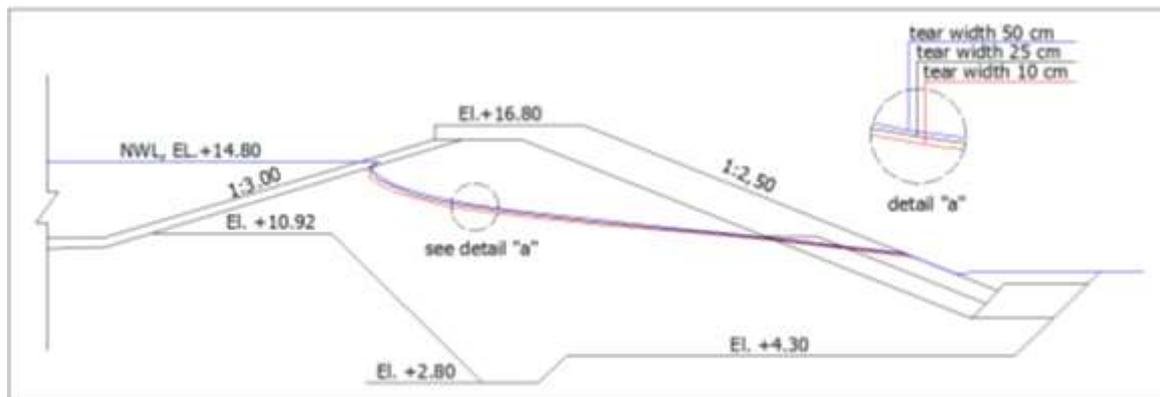
a) phreatic line on damage location on the upper part of geomembrane layer

Figure 4. Flow Pattern (phreatic lines) on the dam body with various damage locations and defect width in the geomembrane layer.

The damage in the geomembrane on the dam body can conclude that as the defect width increases and the defect location decreases, the seepage discharge will increase. If there is no damage to the geomembrane and the resulting seepage discharge is constant. The phreatic level is affected by the width of the defect. The wider the defect, the higher the phreatic level. However, the flow pattern at each defect width at the same location showed insignificant differences (Figure 4).

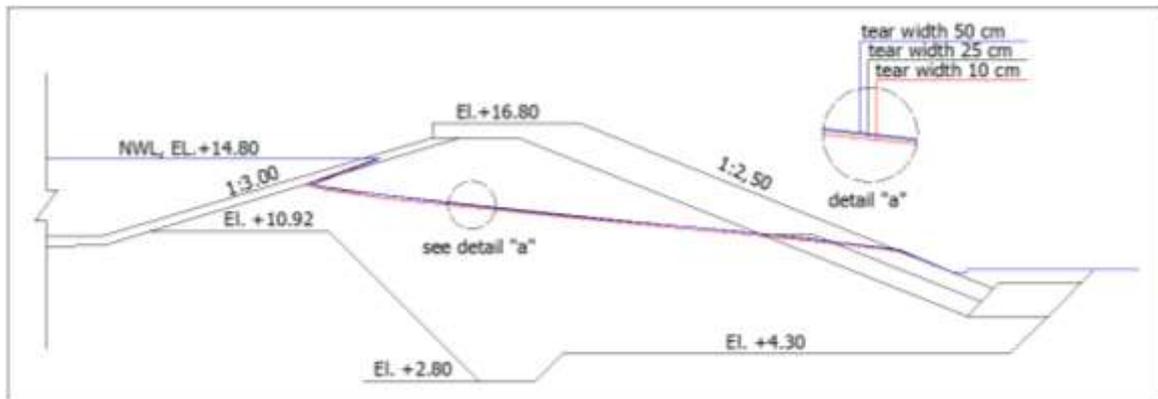
b) phreatic line on damage location on the middle part of geomembrane layer

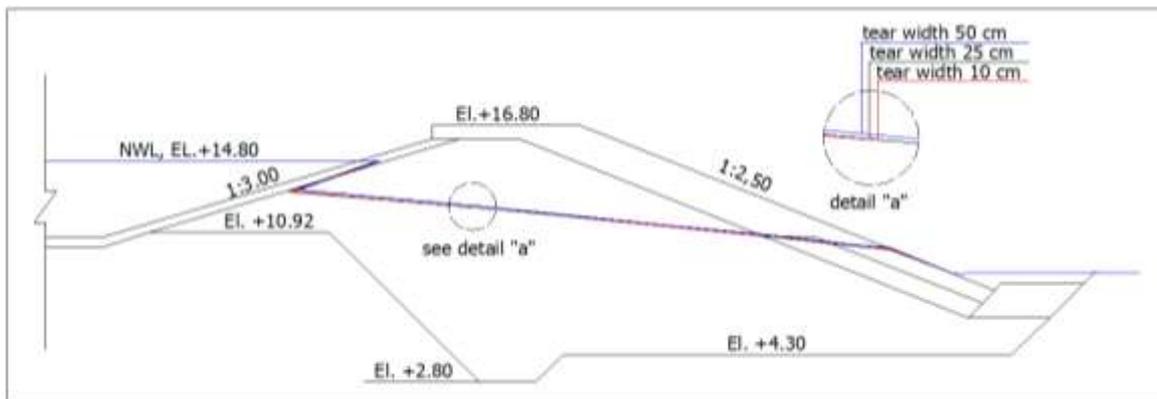
c) phreatic line on damage location on the lower part of geomembrane layer

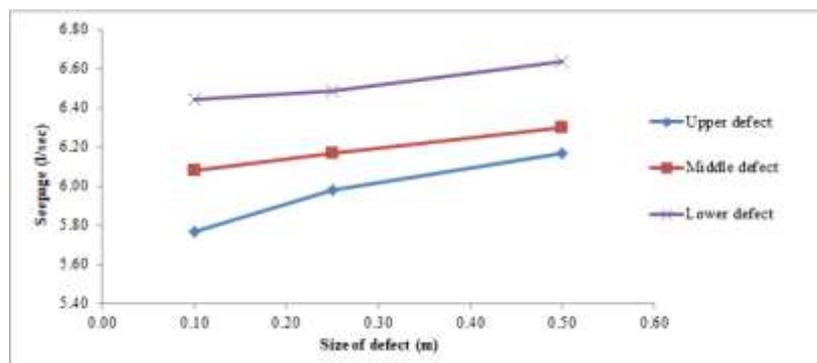
Figure 5. The influence of the size and location of the defect to the seepage discharge

The analysis results show that the amount of seepage discharge for defect widths of 10, 25 and 50 cm is 2.71×10^{-5} , 2.76×10^{-5} and 2.79×10^{-5} m³/s/m respectively. The bigger the defect, the greater the seepage discharge through the dam's foundation and body. The amount of seepage discharge for a 10 cm defect width is 5.23 l/s or 1.94% of the mean annual inflow. The seepage discharge for the 25 cm defect width was 5.33 l/s or 1.98% of the mean annual inflow. Furthermore, the seepage discharge for a defect width of 50 cm is 5.38 l/s or 2.00% of the annual mean inflow. The amount of seepage discharge that occurs is less than the permit seepage discharge in terms of quantity. The allowable
