# The Influence of Damage to the Geomembrane Layer on the Seepage Pattern and Discharge at the Homogeneous Embankment Dam

**Abstract.** Placing the geomembrane layer on the upstream slope can control the seepage in homogeneous dams. Poor geomembrane design, construction and maintenance caused damage to the geomembrane that caused a leak through the dam body. This study discusses the effect of damage on the geomembrane layer at the homogeneous embankment dam on the seepage pattern and discharge. The study location is in the Sianjo Anjo dam, Aceh Singkil district, a homogeneous dam with a geomembrane layer located in the dam body's upstream part. The damage of the geomembrane layer is assumed caused by the various defect of locations and size. The results show that the seepage pattern (phreatic line) tends to be weak in the geomembrane layer without damage. Meanwhile, if the geomembrane layer is damaged, the larger the defects' width, the higher the phreatic line. However, the seepage pattern that occurs shows insignificant or almost the same. The seepage discharge increases with increasing defect width and decreasing defect location.

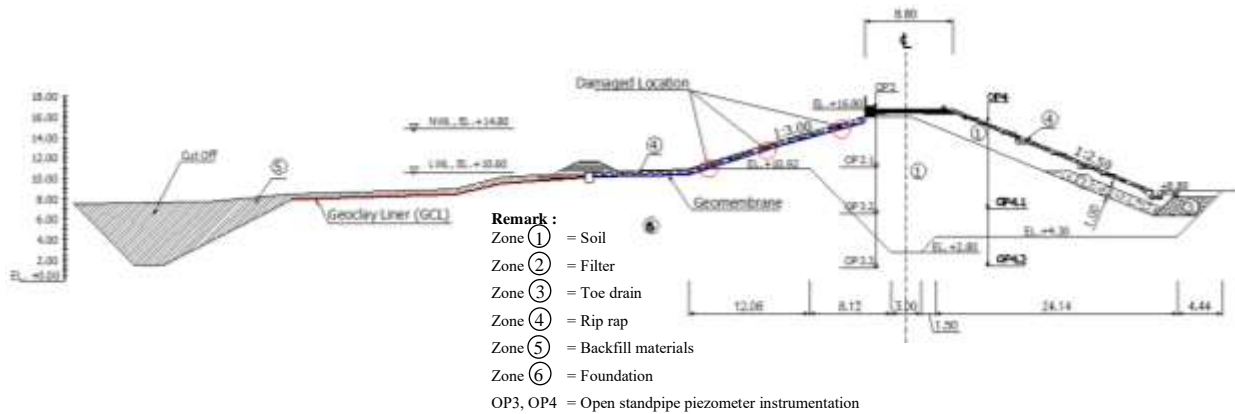
**Figure 2.** Cross Section of Sianjo Anjo Dam 0+280

The Sianjo Anjo Dam was completed in 2010. The benefits of the Sianjo-anjo Reservoir construction are as follows: delivery of clean water for households, irrigation, and supporting tourism development. The Sianjo Anjo Dam type is a homogeneous embankment dam with embankment material in the form of silty sand. The dam body's length is 192.65 m, on the upstream slope a layer of geomembrane is installed as an impermeable layer. Figure 2 shows a cross section of the Sianjo Anjo

dam reviewed in this study at sta 0 + 280 and the location of the damage assumed to occur in the geomembrane layer [3, 4, 5].

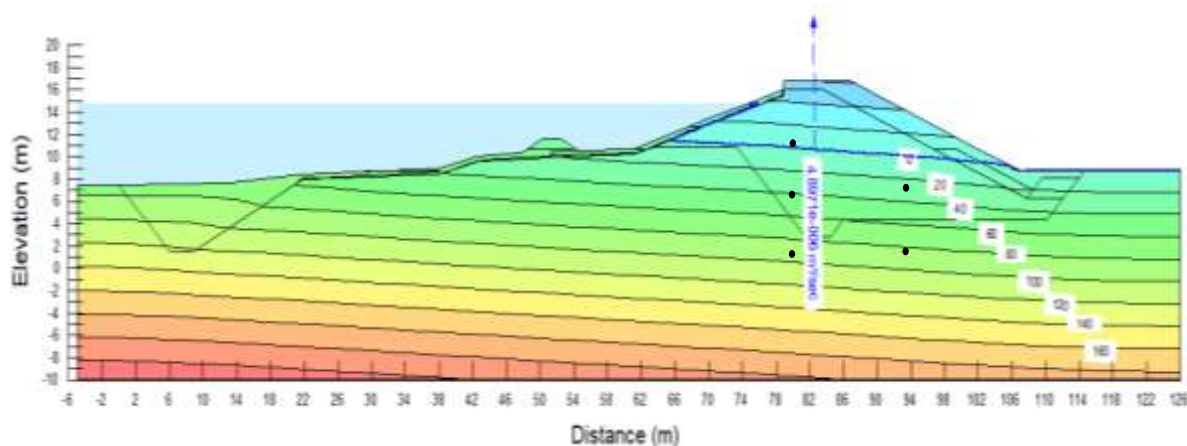
Figure 3. Analysis Result of Seepage in Existing Condition

The results of the seepage analysis of the existing conditions, as shown in Figure 3 show that if the geomembrane layer is not damaged, the phreatic level in the body of the dam tends to be lower. The seepage rate through the dam is  $4.8971 \times 10^{-6}$  m<sup>3</sup>/s/m. With a dam body length of 192.65 m, it was found that the seepage discharge was obtained of 0.943 l/s. Furthermore, the seepage discharge is close to the discharge measured on the v-notch instrument of 0.909 l/s.

The seepage analysis results under existing conditions (without damage) show that the dam body's phreatic level tends to be lower. The low phreatic level is because there is an intact geomembrane layer in the dam's upper reaches. The seepage analysis in the supposedly damaged geomembrane layer shows that the greater the defect's width, the higher the phreatic line. However, the flow patterns that occur show an insignificant difference or nearly the same. During this time, the seepage discharge that occurs shows that with an increase in the defect's width and a decrease in the location of the defect, the seepage discharge will increase. The results show that damage to the geomembrane layer will result in leakage through the dam body. Therefore, a good design, construction and proper maintenance of the dam body's geomembrane layer is necessary so that leakage through the dam body can be avoided so that the dam body's safety can be awake.

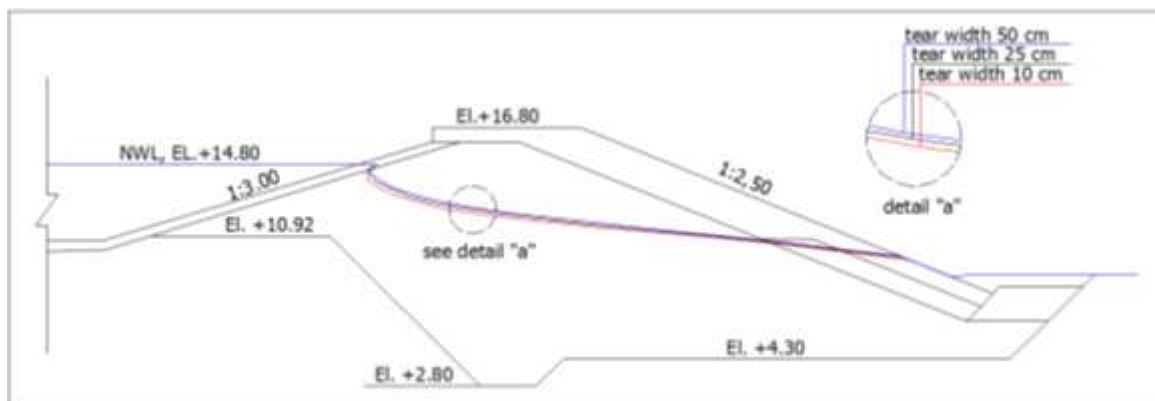
a) phreatic line on damage location on the upper part of geomembrane layer

**Figure 4.** Flow Pattern (phreatic lines) on the dam body with various damage locations and defect width in the geomembrane layer.

The damage in the geomembrane on the dam body can conclude that as the defect width increases and the defect location decreases, the seepage discharge will increase. If there is no damage to the geomembrane and the resulting seepage discharge is constant. The phreatic level is affected by the width of the defect. The wider the defect, the higher the phreatic level. However, the flow pattern at each defect width at the same location showed insignificant differences (Figure 4).

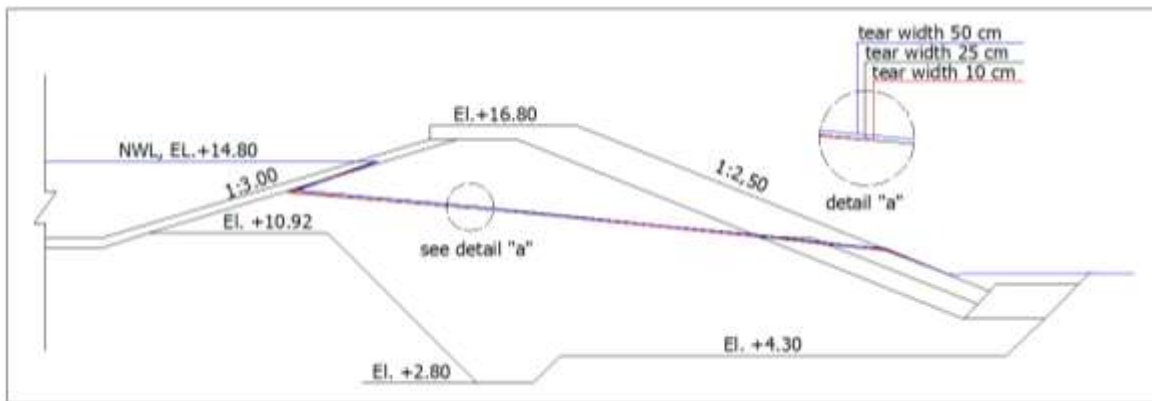
c) phreatic line on damage location on the lower part of geomembrane layer

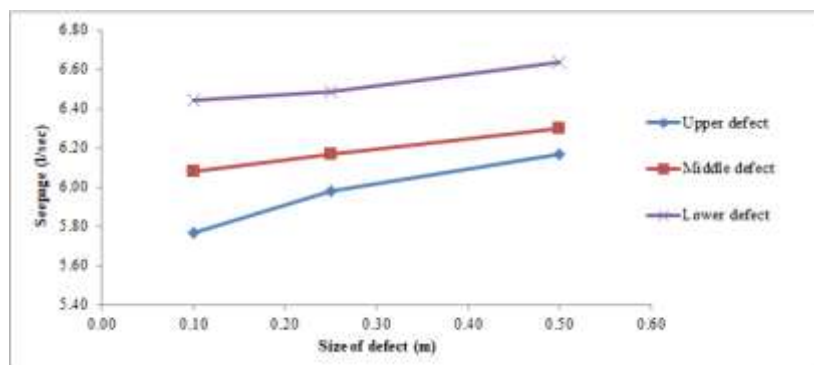
**Figure 5.** The influence of the size and location of the defect to the seepage discharge

The analysis results show that the amount of seepage discharge for defect widths of 10, 25 and 50 cm is  $2.71 \times 10^{-5}$ ,  $2.76 \times 10^{-5}$  and  $2.79 \times 10^{-5}$   $m^3/s/m$  respectively. The bigger the defect, the greater the seepage discharge through the dam's foundation and body. The amount of seepage discharge for a 10 cm defect width is 5.23 l/s or 1.94% of the mean annual inflow. The seepage discharge for the 25 cm defect width was 5.33 l/s or 1.98% of the mean annual inflow. Furthermore, the seepage discharge for a defect width of 50 cm is 5.38 l/s or 2.00% of the annual mean inflow. The amount of seepage discharge that occurs is less than the permit seepage discharge in terms of quantity. The allowable
